Department of Natural Resources
Resource Assessment Service
MARYLAND GEOLOGICAL SURVEY
Richard A. Ortt, Jr., Director

REPORT OF INVESTIGATIONS NO. 89

**ALLEGANY COUNTY HIGHWAY ROCK CUT INVENTORY AND
SLOPE FAILURE POTENTIAL**

June 2023

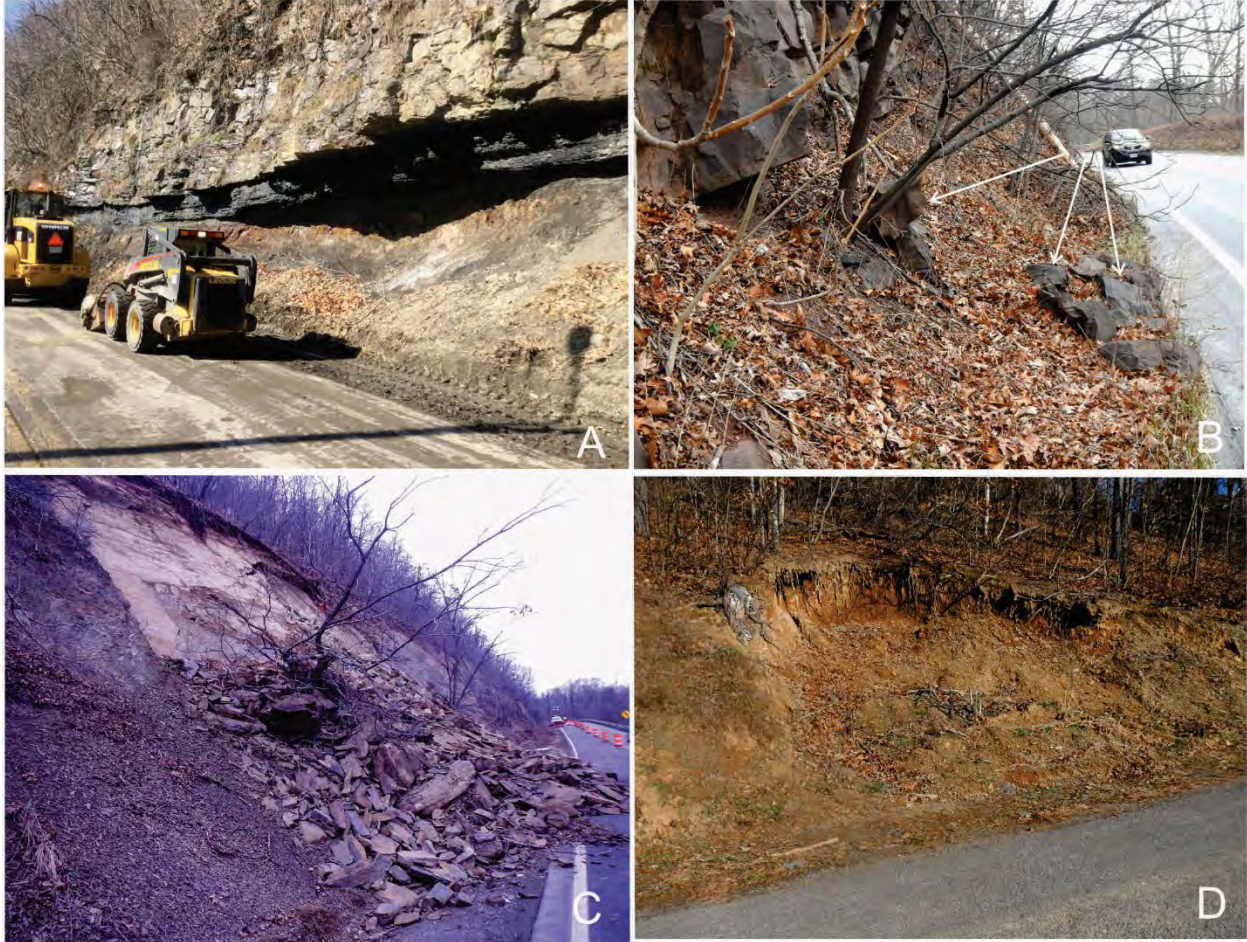
Figure 14. Type of slope failures and resulting hazards identified during this study. A, Rockfall. B, Rock roll. C, Rockslide. D, Slump (rotation) scar.

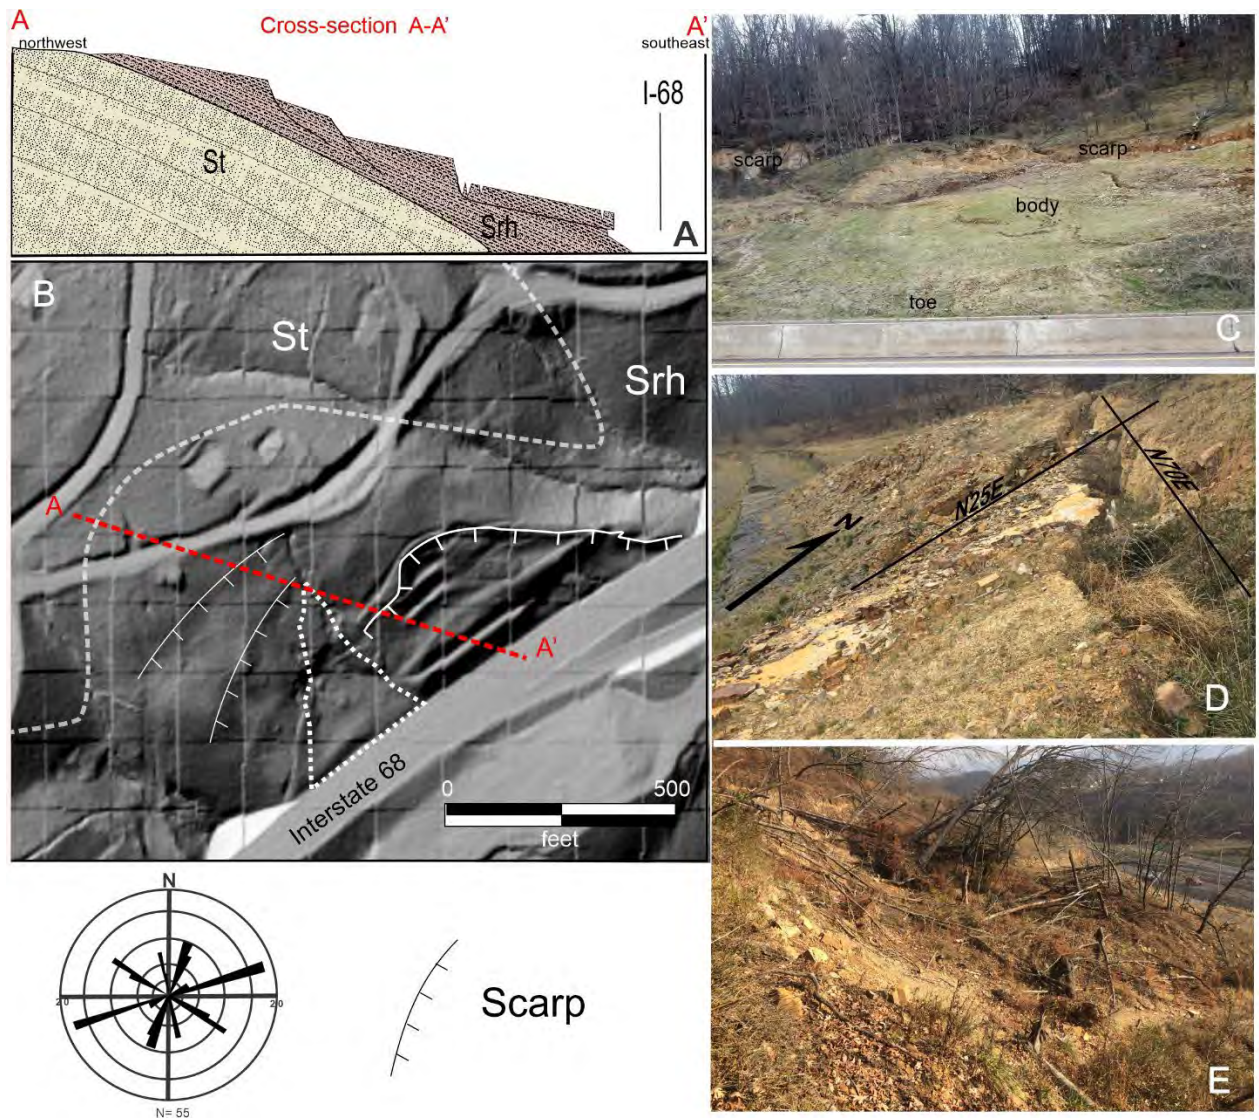
Figure 21. Overview of the Haystack Mountain rockslide area. A, Cross-section of the slide mass along section line A-A'. B, LiDAR image of slide area showing existing and earlier slide scarps (MD iMAP, 2018). Rose diagram illustrates dominant and ancillary joint fracture orientations. C, View of slide area from the east-bound lanes of Interstate 68. D, Rupture fissure illustrating recent detachment. E, Undulating upper surface of the body of the slide mass with disturbed vegetation.

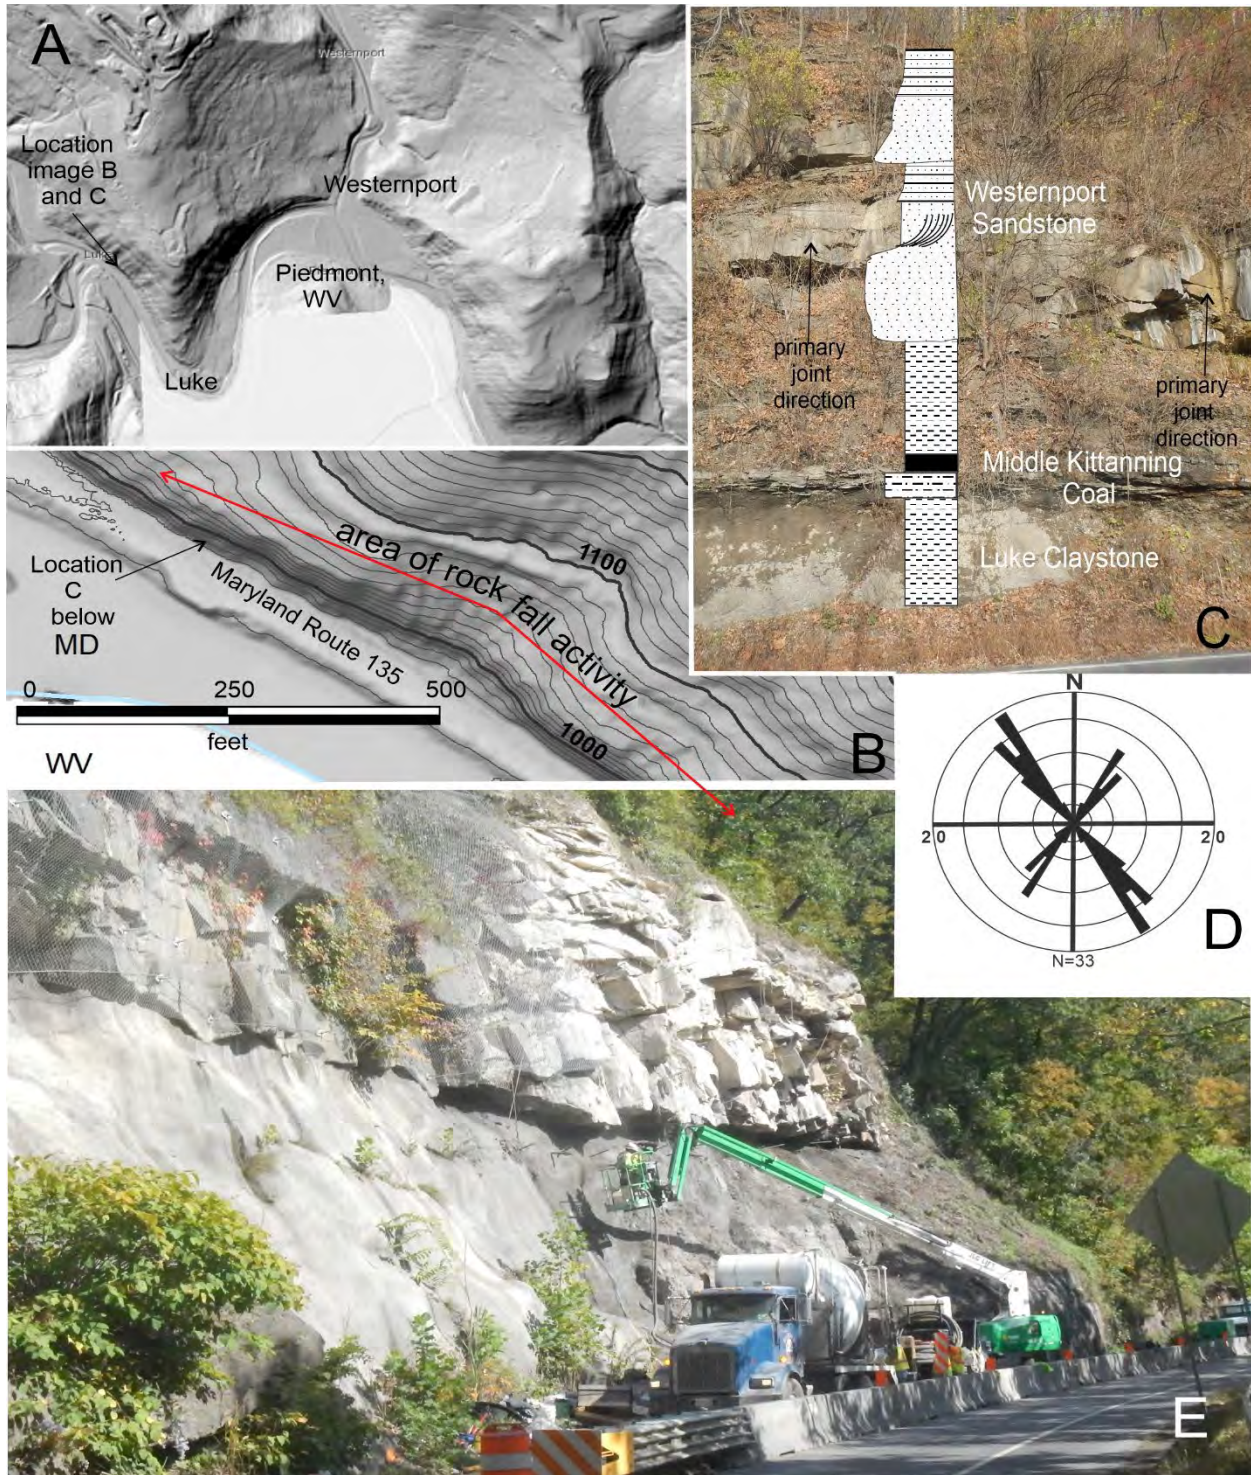
The predominant factor in rockfall at this location is the steep slope formed by flat-lying Pennsylvanian strata. Subvertical cliffs with slope angles up to 86 degrees occur along a southwest facing slope next to MD Route 135. The stratigraphy, which consists of interbedded lithologies of varying competence, contributes substantially to the potential for rockfall. Intervals of fine-grained strata that are easily eroded (shale, siltstone, and coal), alternate with thick-bedded to massive, well-cemented sandstones. The sandstones are undercut at their base by the easily eroded shales, and overhanging ledges of massive sandstone result (Figure 22C).

Figure 22. Overview of the rockfall at Bloomington. A, B, LiDAR images of the area along MD Route 135 near the mouth of the Savage River (MD iMAP, 2018). C, Stratigraphy of the rock strata at the study site. D, Rose diagram of joint orientations measured along MD 135 within the lower Allegheny Formation. Notice how the main joint set is subparallel to the Potomac River and state route. E, Grouting and fencing retainment mitigation conducted during 2021.

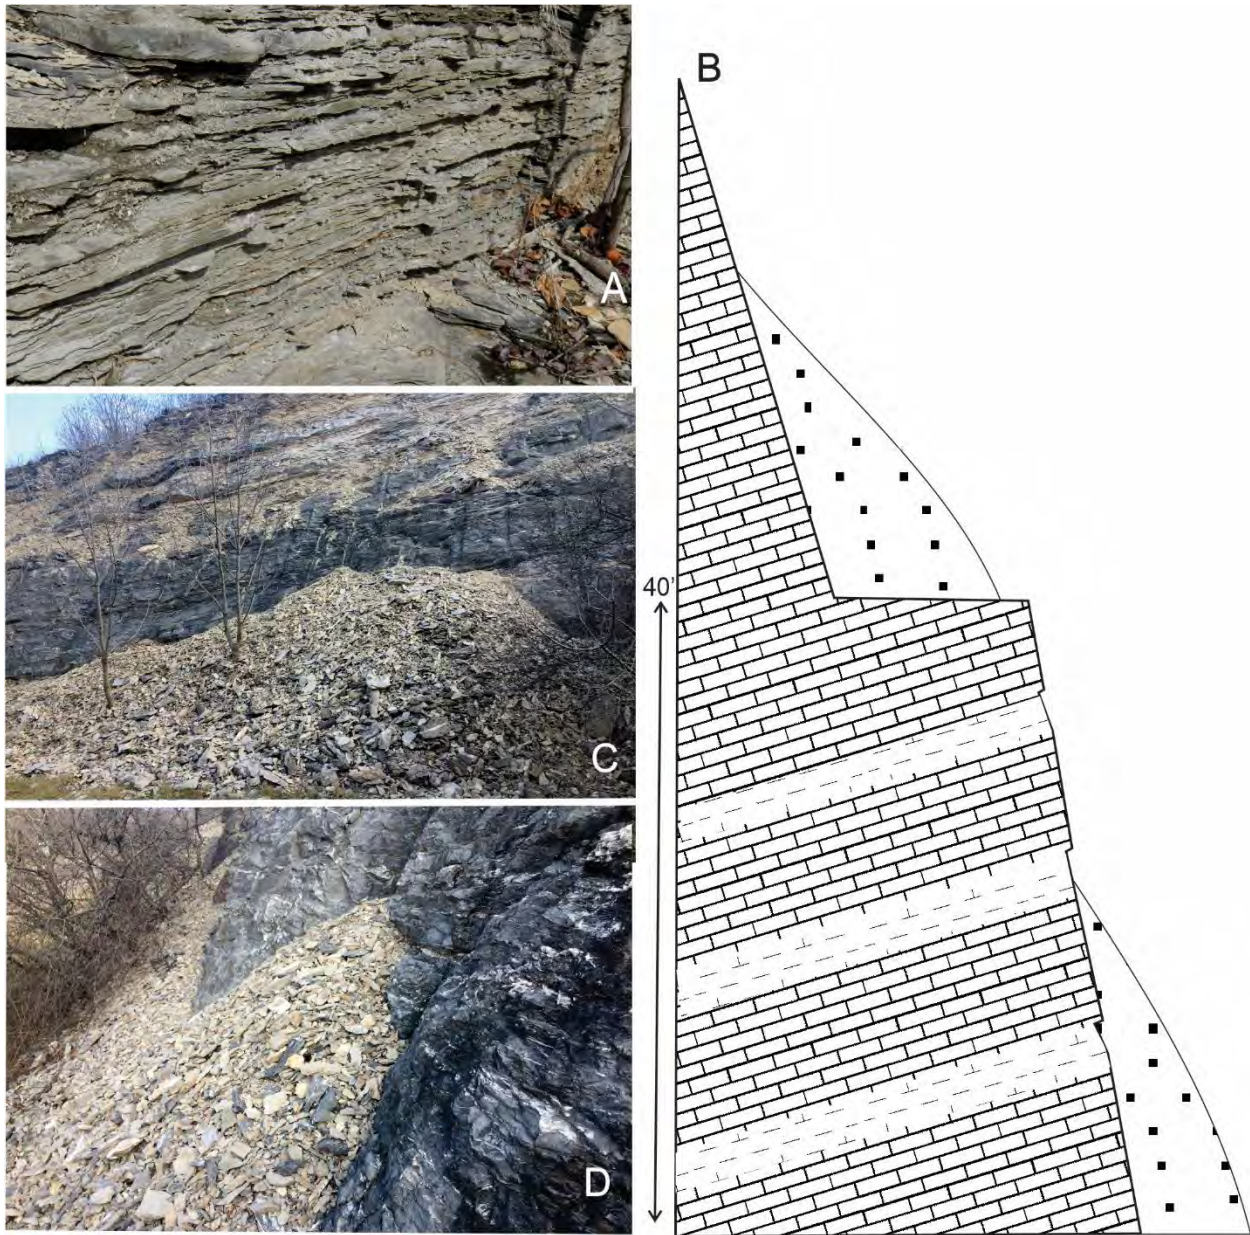
Figure 23. Example of extensive rock roll along Interstate 68 on Martin Mountain. A, Thinly bedded limestone of the Tonoloway Formation. B, Diagrammatic sketch of dipping limestone strata and debris cones along eastbound lane of I-68. C, Basal outcrop debris apron at the study location. D, View of coalescing debris aprons.

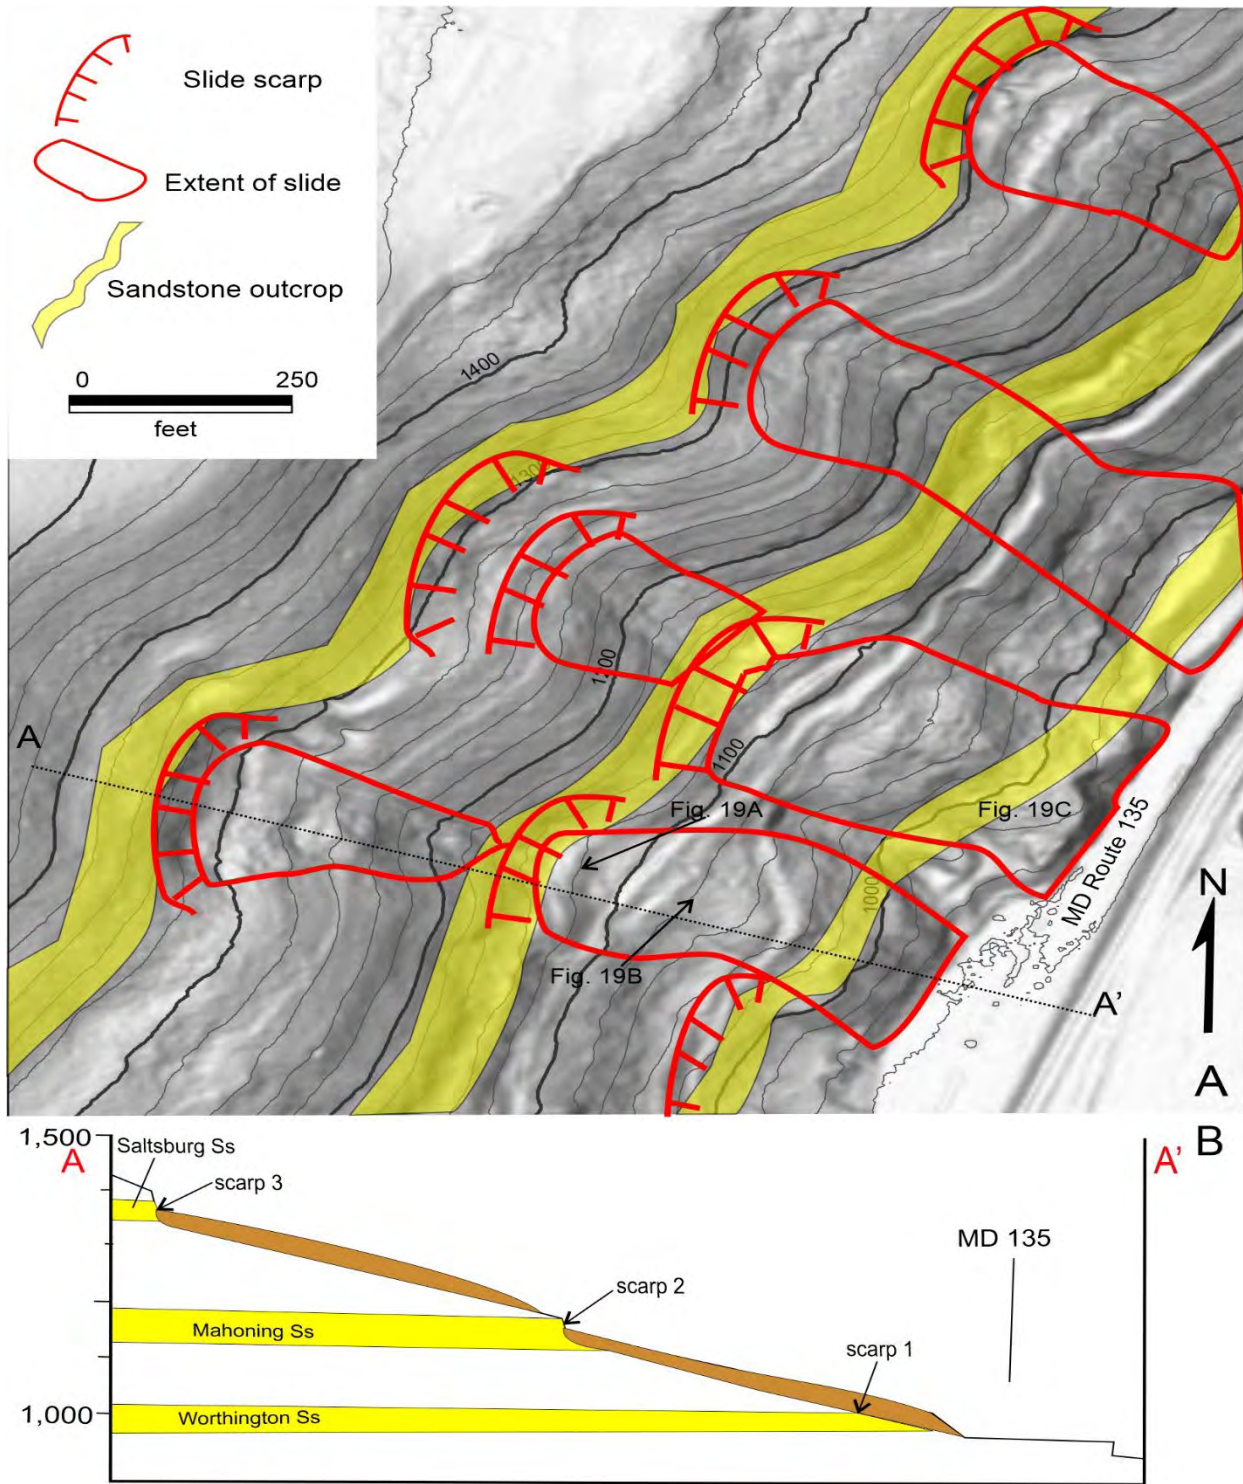
This location illustrates that larger slump/rotation failures tend to occur where massive lithologies are interbedded with easily erodible lithologies. While this is characteristic of the Pennsylvanian strata in the Appalachian Plateau Physiographic Province, units with similar interbedded massive lithologies in the Valley and Ridge Physiographic Province (e.g. Foreknobs Formation) may also provide conditions prone to large slumps and rotations.

Figure 24. Example of slumps/slides at Luke, Maryland. A, LiDAR image of slopes along the Potomac River at Luke, Allegany County, Maryland. Yellow bands are approximate outcrop belts of significant sandstone beds. Slumps/slides appear to be controlled by an outcrop of the sandstone units. B, Specific sandstone units interpreted from nearby outcrops and unpublished geologic mapping (Brezinski, 2022).

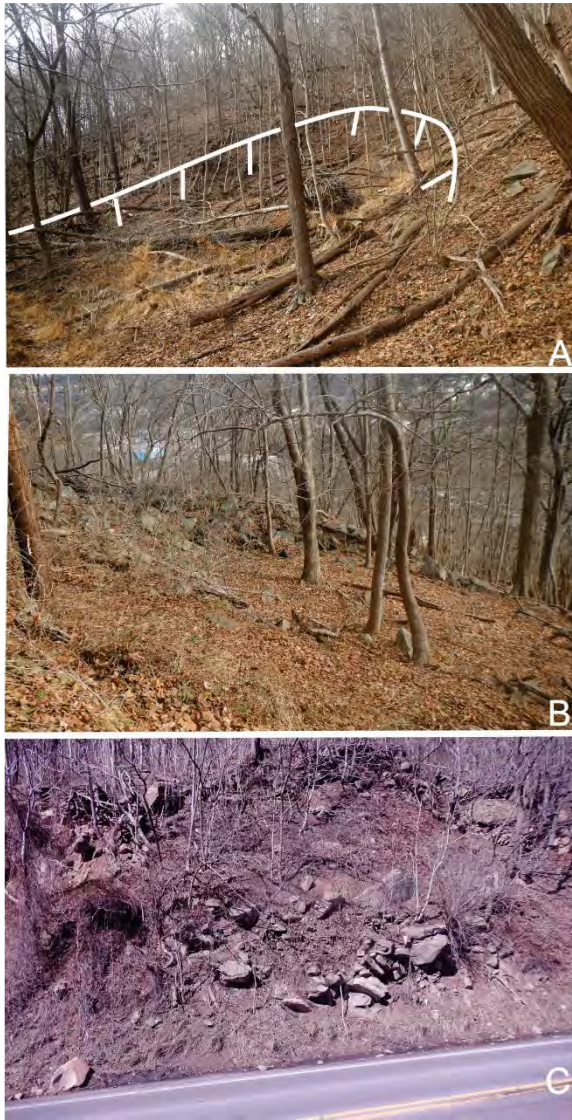
Figure 25. Segments of rotational slumps at Luke, Maryland. A, Arcuate scarp of a single rotational slump. See Figure 24A for location. Note disturbed vegetation from unstable slope. B, View of the nearly flat upper surface of an individual slump. C, Toe of an individual slump as seen along MD Route 135.

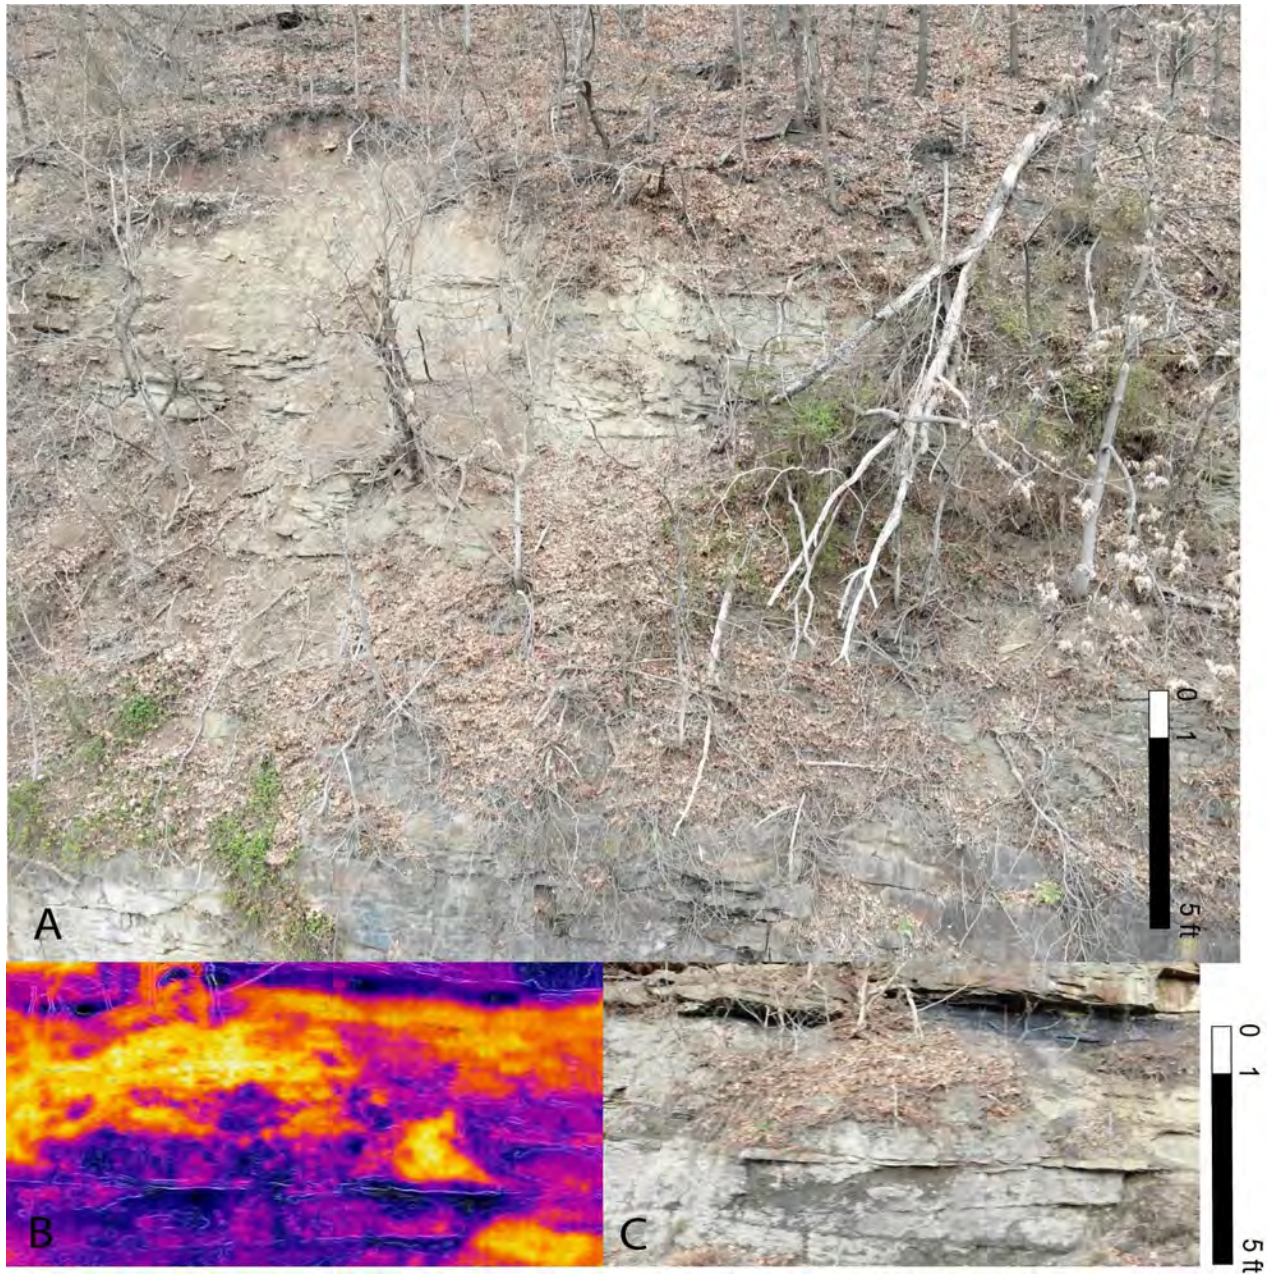
Figure 26. Drone imagery. See Figure 18A for location. A, Slide scarp approximately 50 feet above the road, on the hillside above two massive sandstone layers. Not visible from road level. B, Infrared drone imagery (orange/red = warm, purple/black = cold) of bedrock layers (purple) with water (black) exiting along stratification in the Allegheny Formation. C, Visible drone imagery, same area as B.

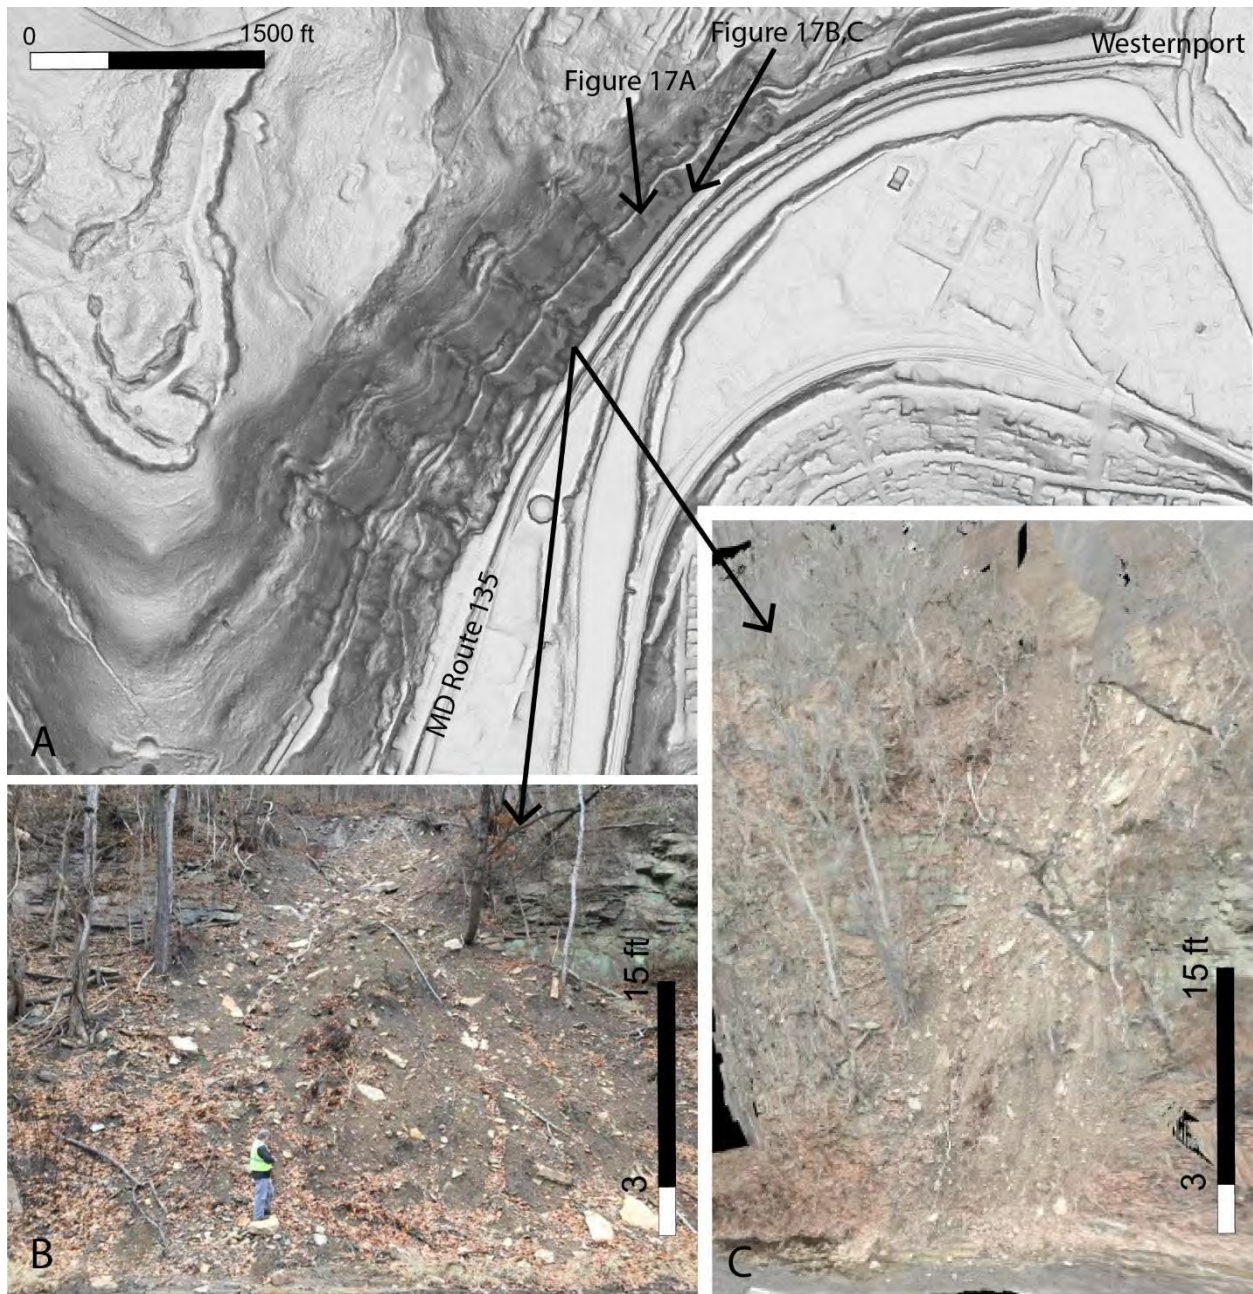
Figure 27. Slope failures. A, LiDAR image showing channel visible on hillslope above MD Route 135 that leads to slide area in photos B and C. Similar channels nearby are also visible. B, Standard photo of the slide area. C, Stitched image of drone photography, same location as B.
