Factors Affecting Karst Spring Turbidity in Eastern Washington County, Maryland

David K. Brezinski, Johanna M. Gemperline, Rebecca Kavage Adams, David W. Bolton,
Maryland Geological Survey, 2300 St. Paul Street, Baltimore, Maryland 21218

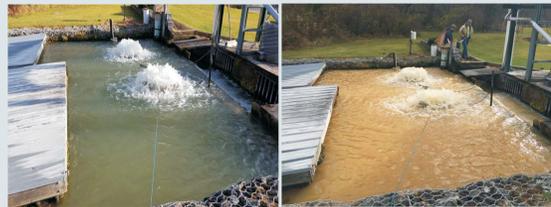
Figure 1. Albert Powell hatchery karst spring during normal flow (left) and during the December 2016 turbidity event (right).

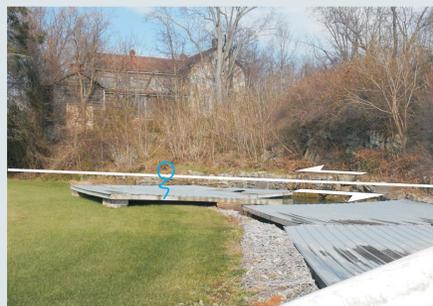
Figure 4. Interpreted trace of cross fault with respect to the Albert Powell hatchery spring (photo is looking northeast from hatchery).
