Department of Natural Resources
Resource Assessment Service
MARYLAND GEOLOGICAL SURVEY
Richard A. Ortt, Jr., Director

REPORT OF INVESTIGATIONS NO. 89

**ALLEGANY COUNTY HIGHWAY ROCK CUT INVENTORY AND
SLOPE FAILURE POTENTIAL**

June 2023

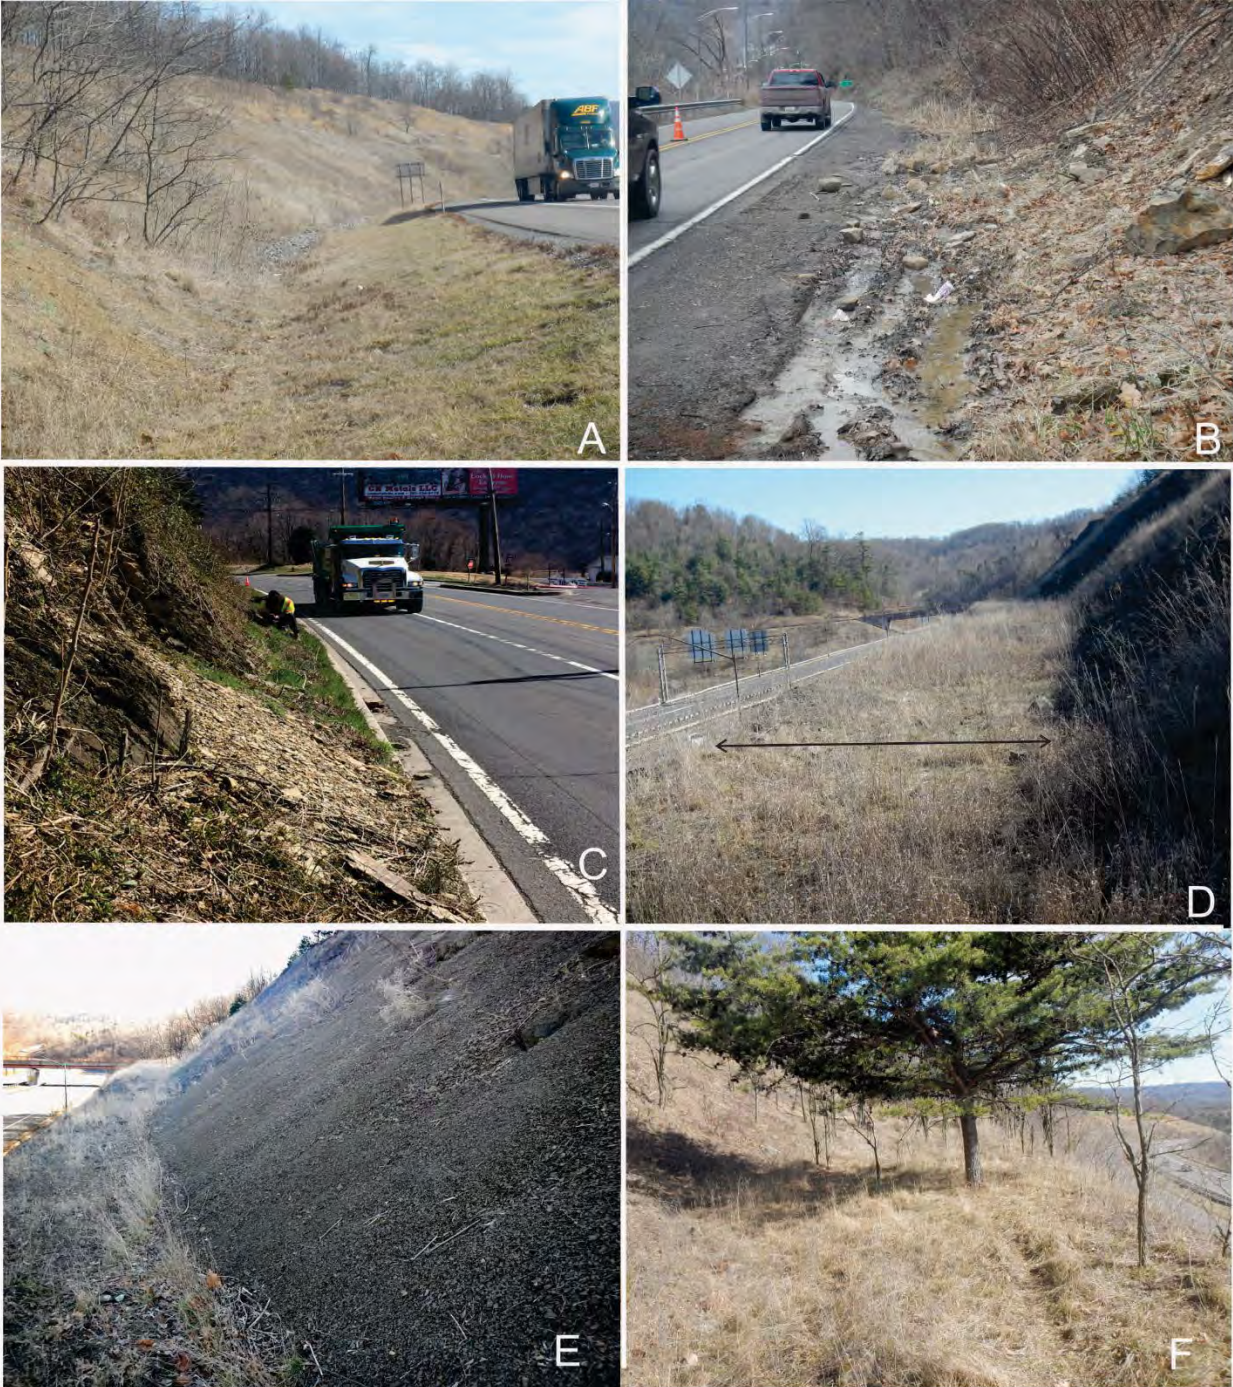
The presence or absence of benches is generally dictated by the height of the exposure. Those exposures less than twenty feet in height rarely have benches. Those greater than forty feet in height typically possessed at least one level of the elevated bench (Figure 9D). Although benches represent elevated catchment areas, when they become filled with debris they can themselves become a launching factor, propelling rolling debris onto the roadway, and beyond roadside catchment (Figure 9E). Thus, filled benches switch from a safety factor to a hazard. When benches become filled, they also tend to spawn vegetation growth (Figure 9F).

Figure 9. Benches and catchments styles and character. A, Catchment shoulder sloping away from the roadway. B, Flat catchment shoulder. C, Shoulder inclined towards the roadway. D, Elevated catchment bench clear of debris. E, Elevated bench nearly filled with debris. F, Elevated bench with woody vegetation.

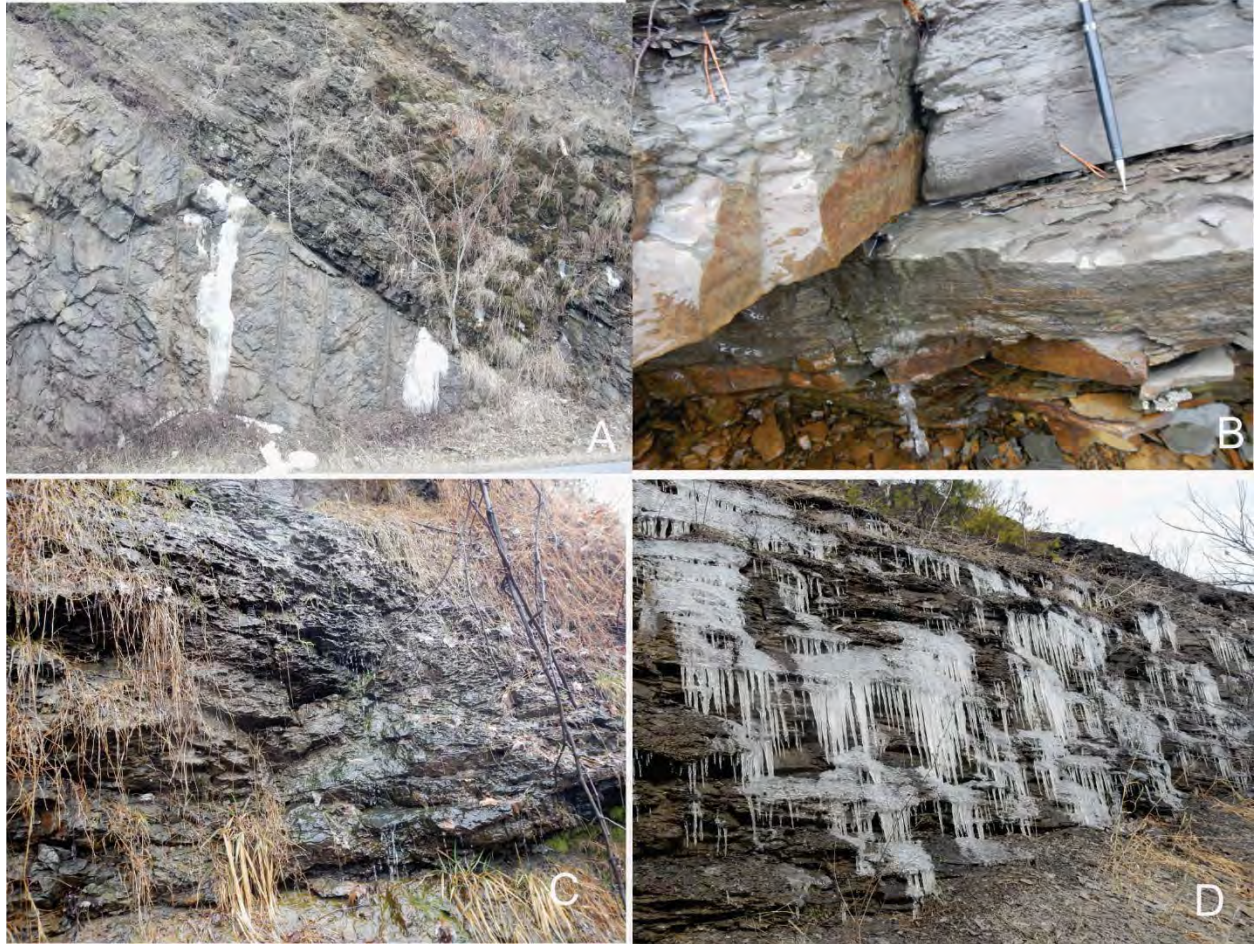
Figure 11. Degrees of variation in the amount and distribution of water on roadside slopes. A, Water seeps along stratification. B, Water seeping along joints and fractures. C, D, Water covering the surface of outcrops.

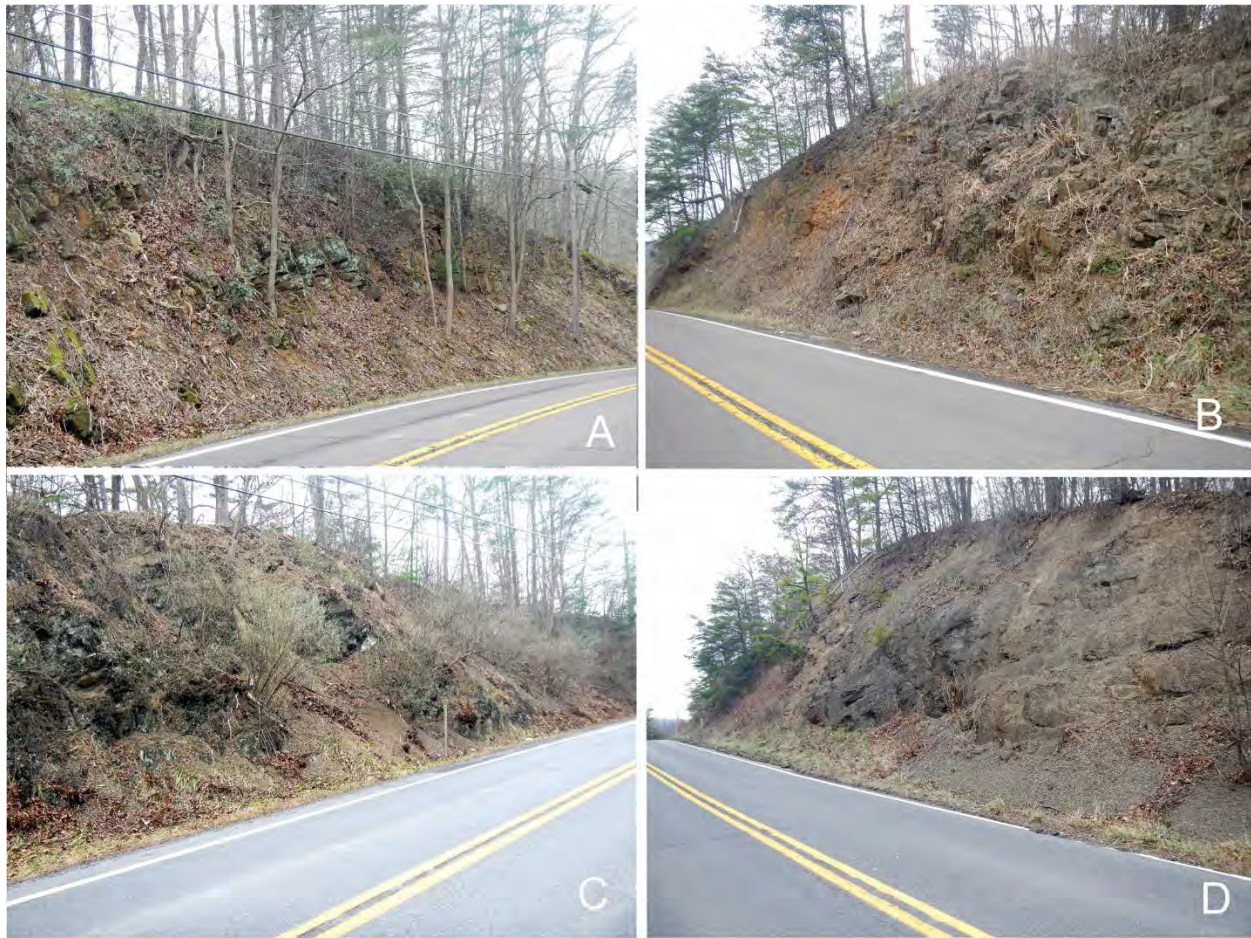
As a general observation, vegetation of all types tends to be better developed where water is present on the outcrop. North-facing slopes maintain moisture that allows increased vegetation development (Figure 12A). Branson and Shown (1989) proposed that north-facing highway slopes tended to contain shrubby vegetation, while south-facing slopes more often

Figure 12. Differences in vegetation between north-facing and south-facing slopes. A, Rooted tree saplings and grasses developed on a north-facing slope of sandstones of the Oriskany Formation. B, South-facing slope from the same road cut as A. This face contains grasses and few shrubs. C, Highly vegetated north-facing slope on shales of the Brallier Formation. Vegetation includes rooted trees, saplings, shrubs, and grasses. D, South-facing slope corresponding to the location shown in C. This slope exhibits only sparse grasses.

displayed grassy and herbaceous flora (Figure 12B). These authors opined that the cause for these vegetation differences was related to the differing levels of solar radiation. They maintained that south-facing slopes were associated with increased levels of sunlight that resulted in elevated temperatures, reduced moisture, and a reduced potential for plant colonization and growth. Furthermore, these authors suggested that increased duration of freeze-thaw potential on north-facing slopes led to greater moisture availability in those locations. It is in this position that most lichens and mosses were observed during the current study (Figure 13A). In contrast, the presence of grassy vegetation on south-facing slopes tended to be present where water was preserved in fractures and partings of the bedrock units (Figure 9B).

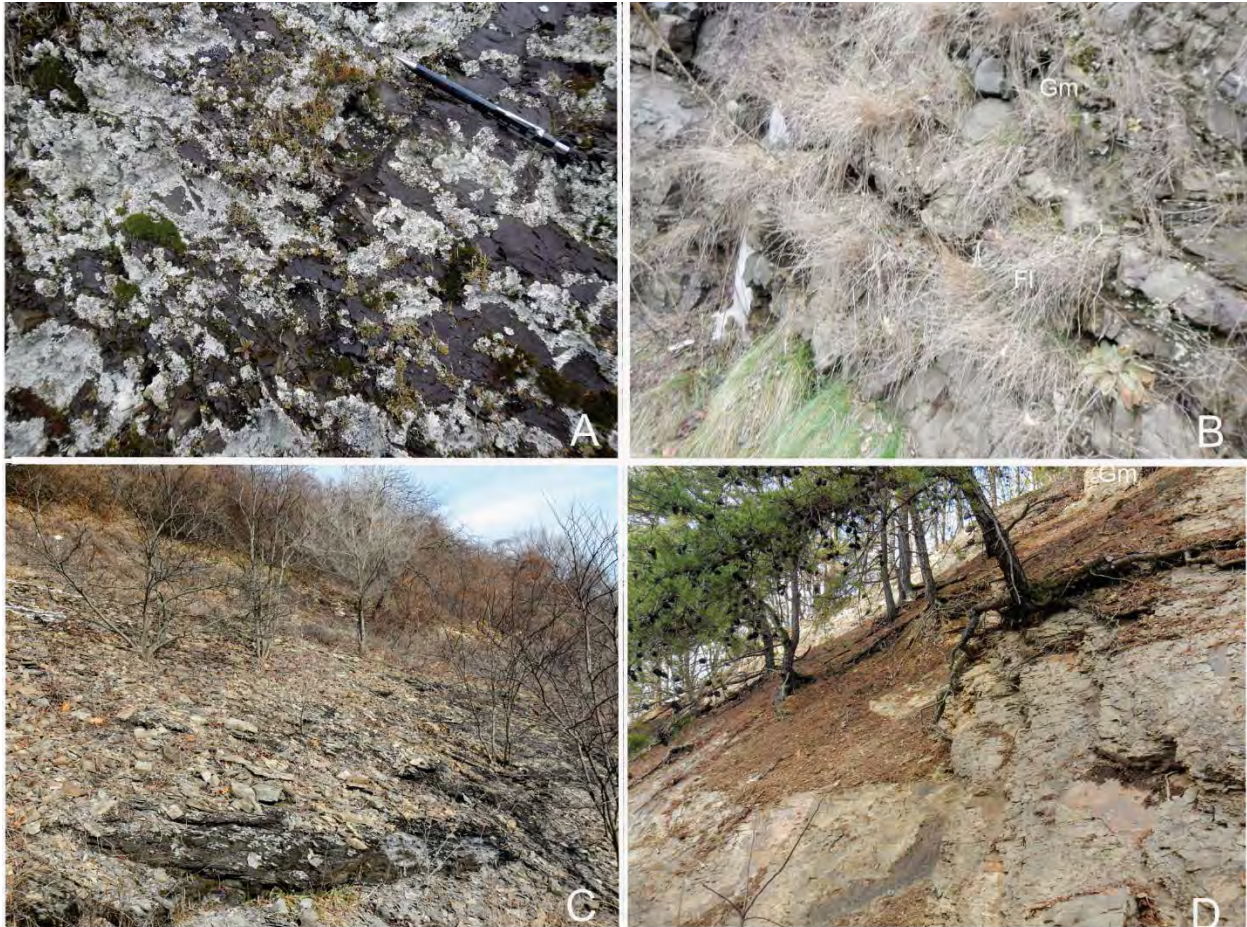
Figure 13. Types of vegetation on roadside slopes. A, Lichens and mosses. B, Grasses in clumps or coatings. C, Rooted saplings. D, Embedded and rooted tree trunks.

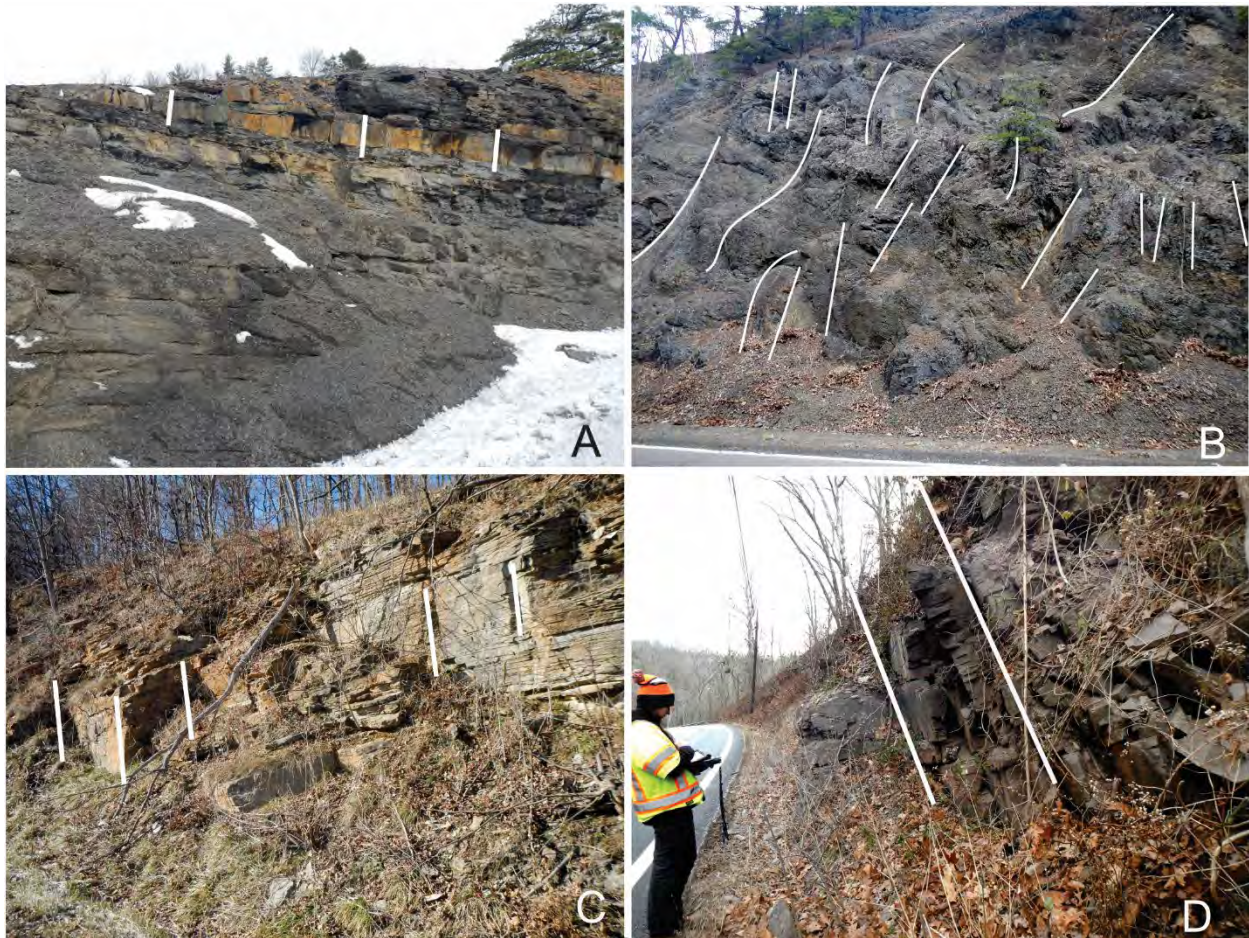
Figure 15. Failure plane character. A, Discontinuous and favorable orientation. B, Discontinuous and random orientation. C, Discontinuous and adverse orientation. D, Continuous and adverse orientation.

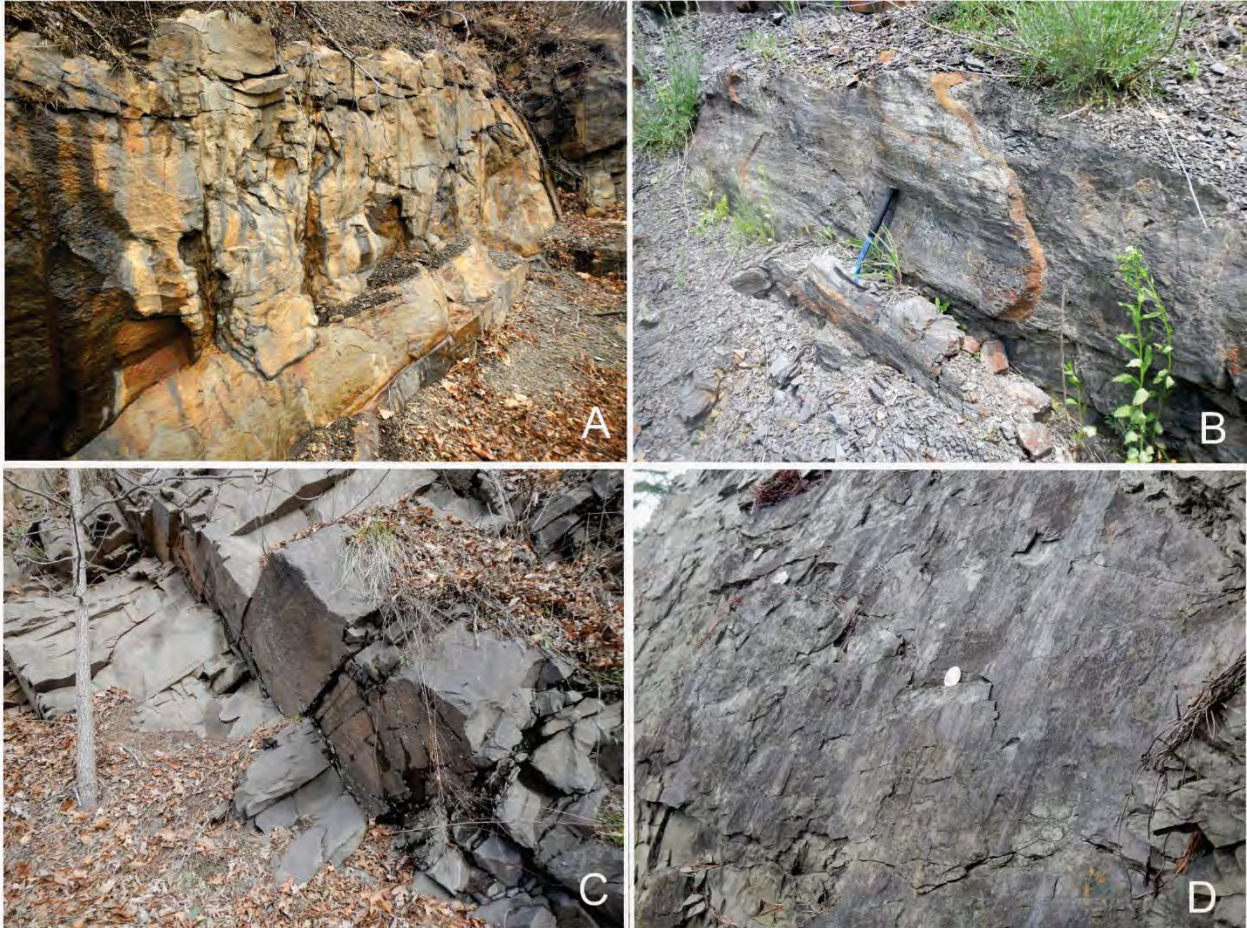
Figure 16. Rock friction. A, Rough and irregular. B, Undulating. C, Planar. D, Slickensides.

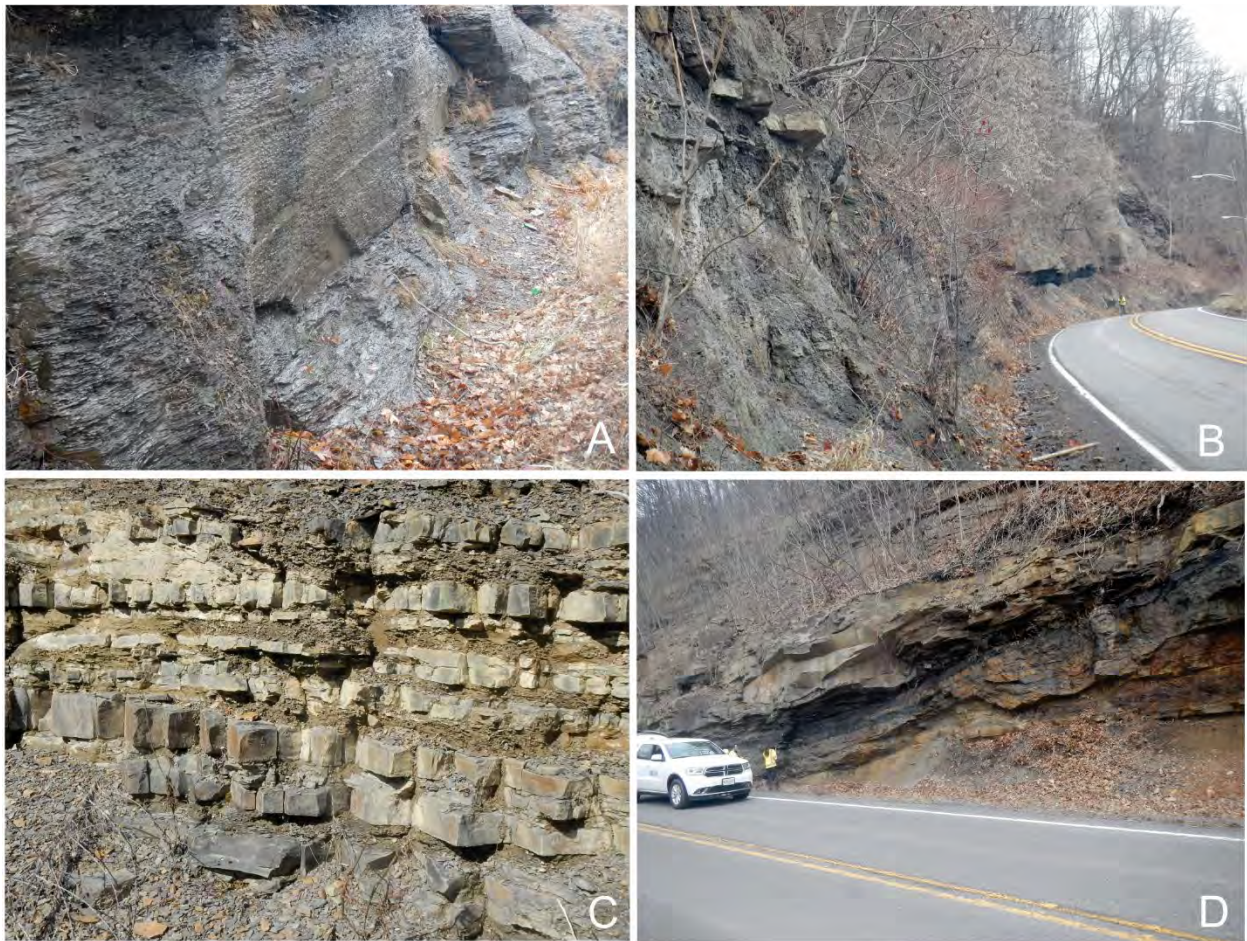
(Figure 17). The rock types least affected by such erosion are massive lithologies such as sandstone, limestone, siltstone, and to a lesser degree, shale (Figure 17A). Because of their homogeneity, these lithologies typically have fewer bedding discontinuities along which weathering and erosion can occur. These lithologies tend to form a subvertical wall with little overhang. In contrast, interbedded lithologies provide varying levels of both weathering and erosion. This

variation is known as differential erosion (= differential weathering of Vanderwater et al., 2005). The pervasiveness of interbedding is also a key component in the potential for the number and prominence of differential erosion features (Figures 17B, C). With greater differential erosion there is an increased likelihood for the formation of overhanging ledges (Figure 17D), which therefore present greater potential for both rockfall and rock roll events.

Figure 17. Differential erosion. A, Minor differential erosion within massive siltstone. B, Occasional differential erosion along sandstone interbeds. C, Many differential erosion surfaces within interbedded sandstone and shale. D, Major differential erosion at the contact between the Pottsville and Mauch Chunk formations.

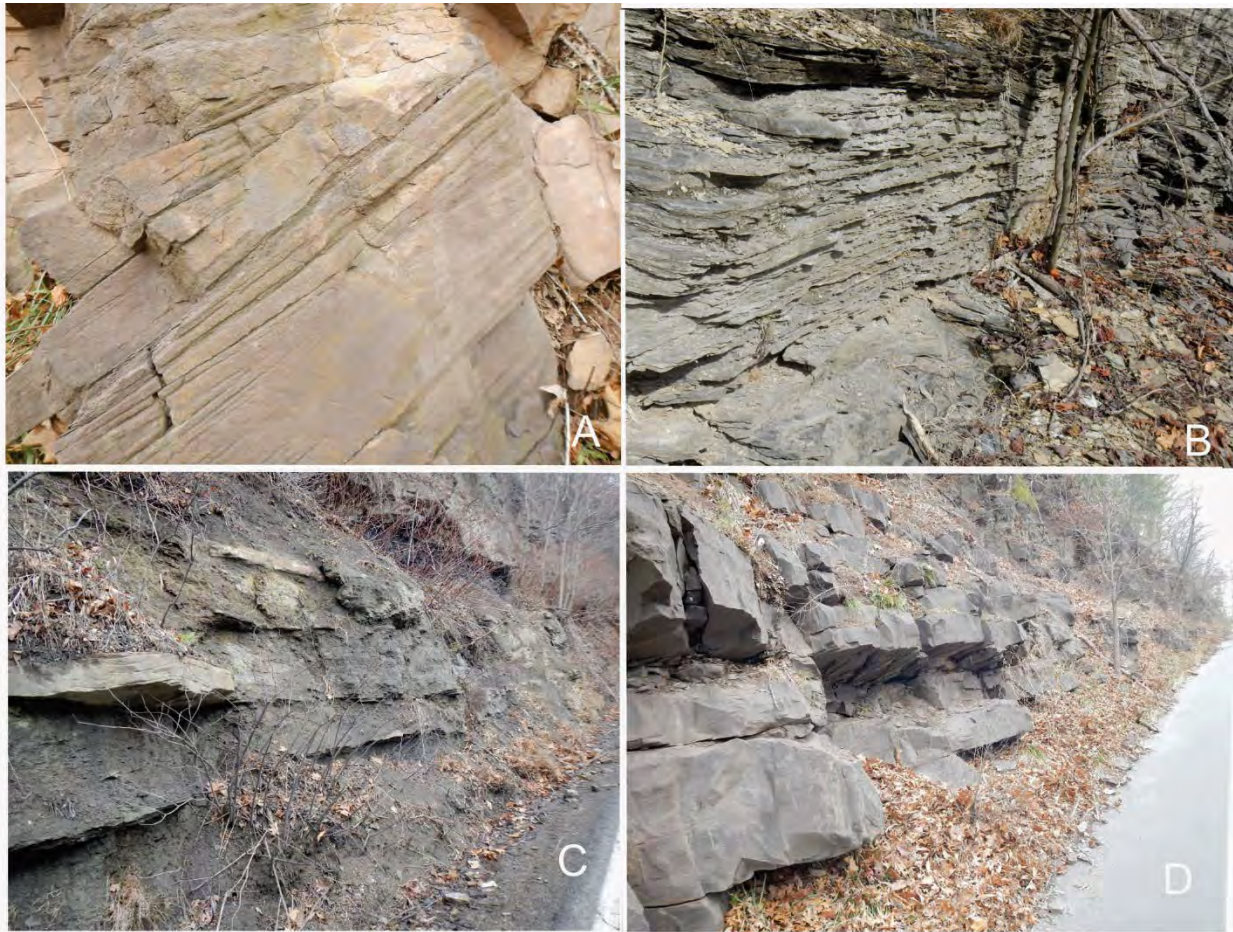
Figure 18. Weathering of outcrops. A, B, Weathered on surface. C, Weathered in relief. D, Weathered with overhanging ledges.

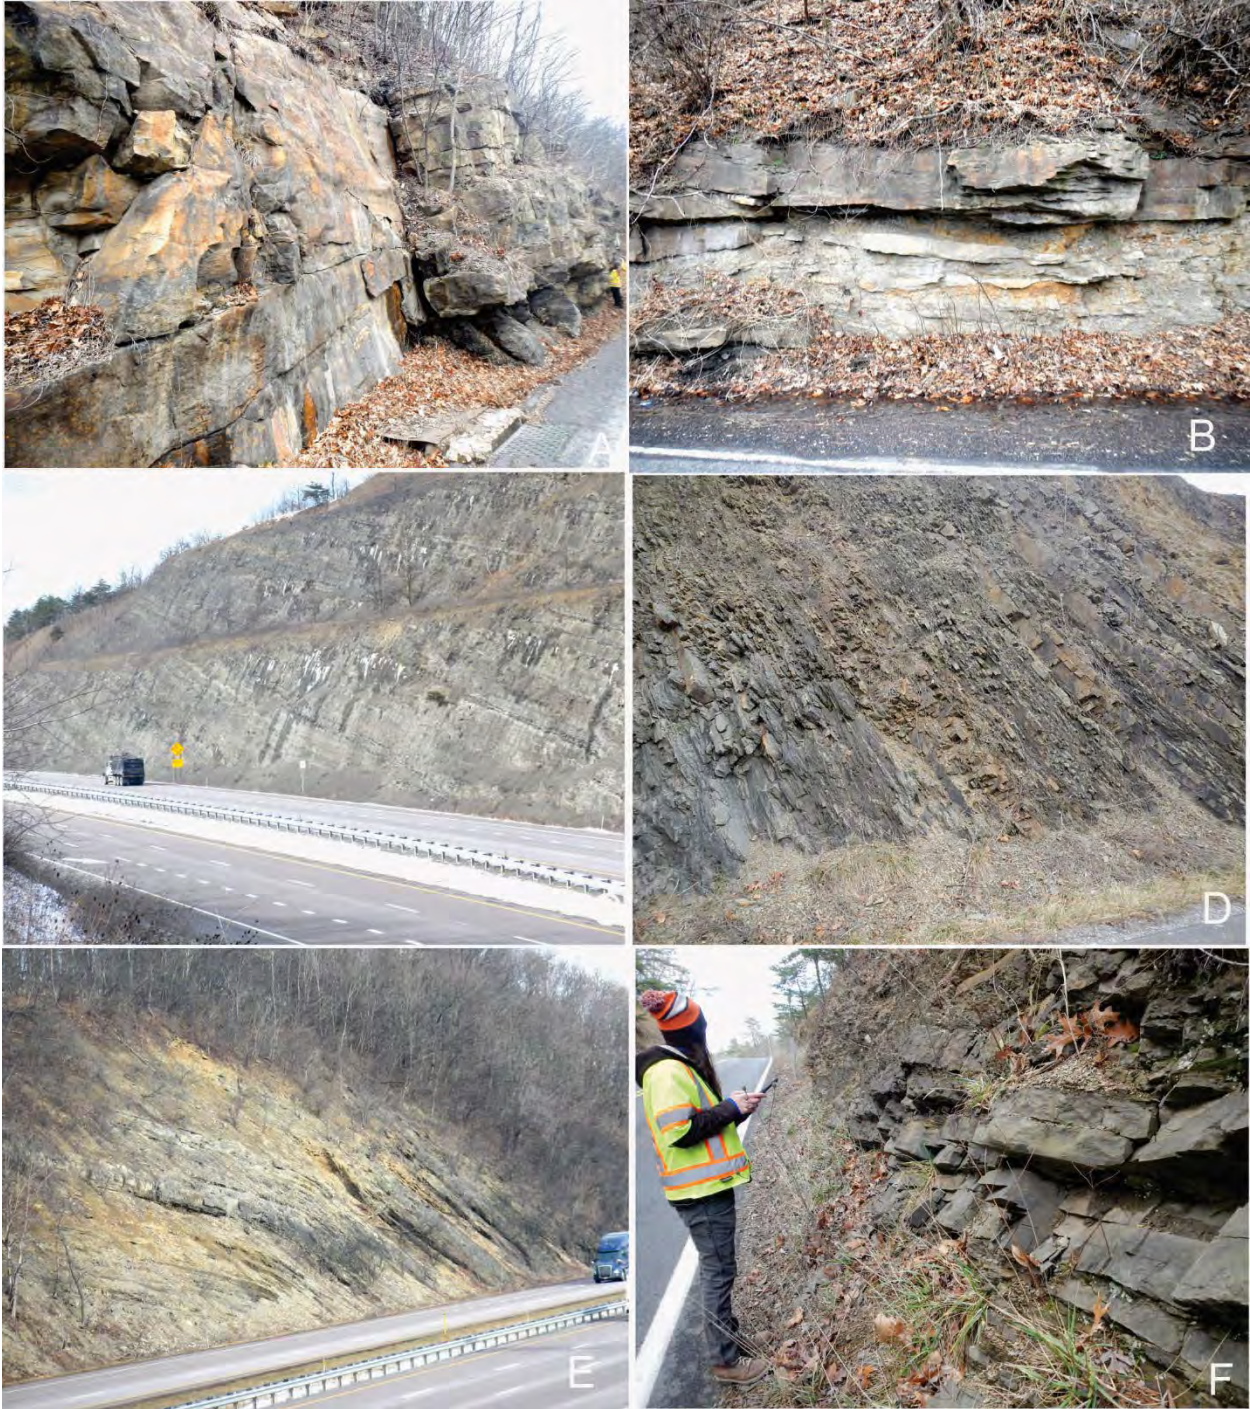
critical to the understanding of the type of potential slope failure. Massive strata, because of their internal structure, tend to have fewer numbers of failure planes and differential erosion surfaces (Figure 19A). This character, especially common when the rocks are nearly horizontal, tends to present steep roadside slopes and often an elevated launching potential. Strata whose dips are oriented parallel to the roadway present greater thickness of strata available for weathering and exposure, although there is a reduced potential for strata decoupling and sliding into the roadway (Figure 19C-D). Strata

dipping into the roadway tends to present greater potential for slides, glides, or detached rock masses where rock can be displaced into the highway right-of-way (Figure 19E). Likewise, this orientation of stratification provides abundant potential for rock roll events where weathered and decoupled blocks can roll down the inclined slope and into the roadway. By contrast, strata dipping away from the roadway can present steep slopes, but a reduced potential for either slides, falls, and rolls (Figure 19F).

Figure 19. Stratification. A, Massive with stratification poorly discernible. B, Stratification horizontal. C, Stratification inclined parallel to road at <45 degrees. D, Stratification inclined parallel to road, >45 degree angle. E, Stratification inclined into roadway. F, Stratification inclined away from roadway.

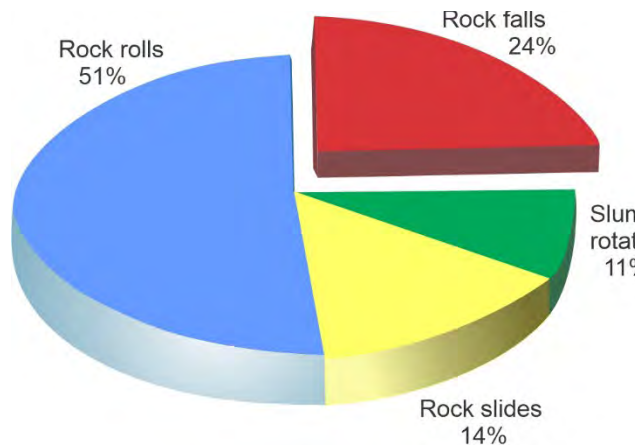
The geographic distribution of studied exposures gives a representative sampling of rock units, physiography, and structural qualities for the bedrock of Allegany County (Figure 19). Figure 20 illustrates the relative potential for the individual types of slope failure as inferred from observations taken from the 195 roadside sites. Rock roll was the most common type of potential slope failure and accounted for more than 51% of the locations. Nearly one-quarter of the locations had some level of rockfall potential (24%), while rockslides and slumps or rotations had a 14 % and 11% failure potential, respectively.

Figure 29. Pie diagram showing relative percentages of potential slope failures identified from roadside exposures in Allegany County, Maryland.

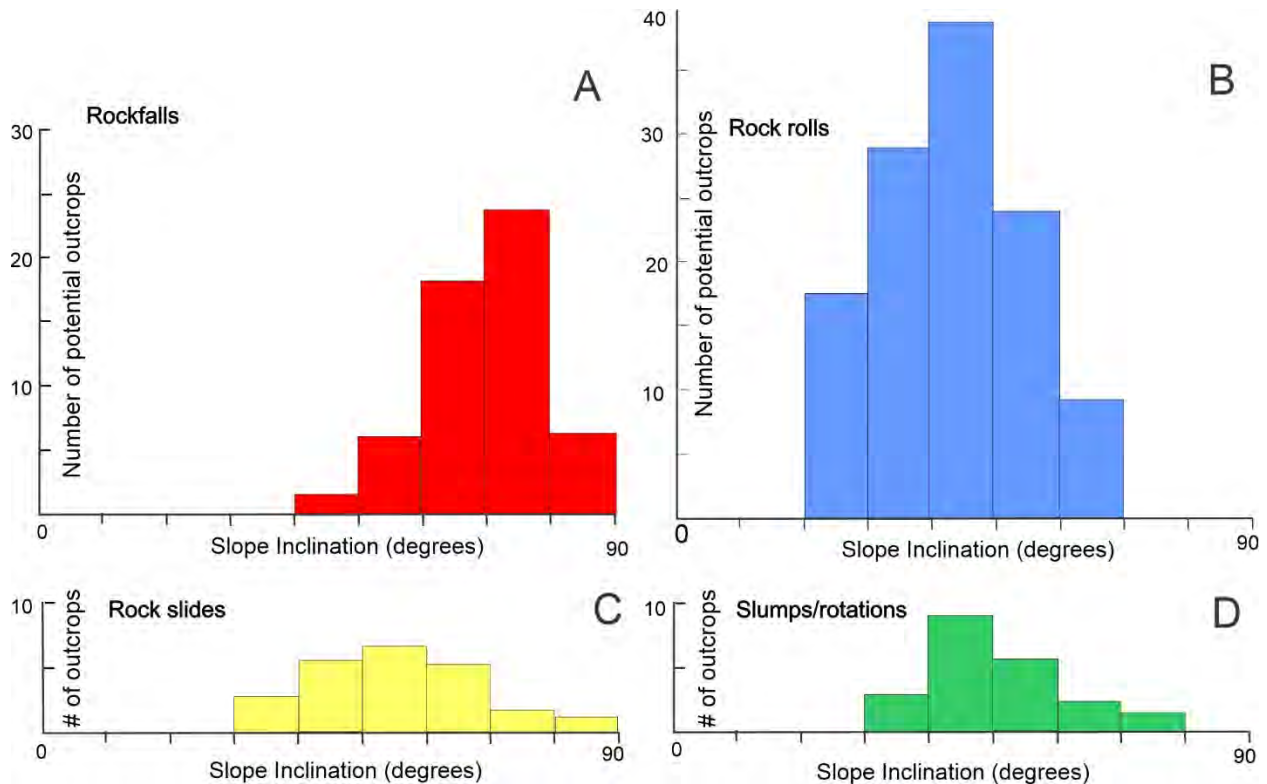
Perhaps one of the most fundamental relationships confirmed by this data set is that steeper slopes produce greater potential for slope failure incidence (Figure 21). Based upon these data, rockfall potential exists in slopes ranging from 40 to 90 degrees. Elevated prospects exist in slopes greater than 70 degrees (Figure 21A).

Interpreted potential for rock roll ranged in slopes of between 20 to 70 degrees (Figure 21B). The greatest interpreted potential was for slopes of between 40 and 50 degrees. Surmised rockslide potential was found for slopes that ranged between 30 and 90 degrees (Figure 21C). Although the inferred potentials were on slopes between 50 to 60 degrees, these slope ranges are largely confined to strata that dip towards the roadway. The potential for slumps and rotations was found to be similar in slope steepness and rockslides (Figure 21D). The range for these potential failures was from 30 to 80 degrees, with an identified peak probability between 40 to 50 degrees.

Figure 30. Embankment steepness and its relationship to slope failure type.

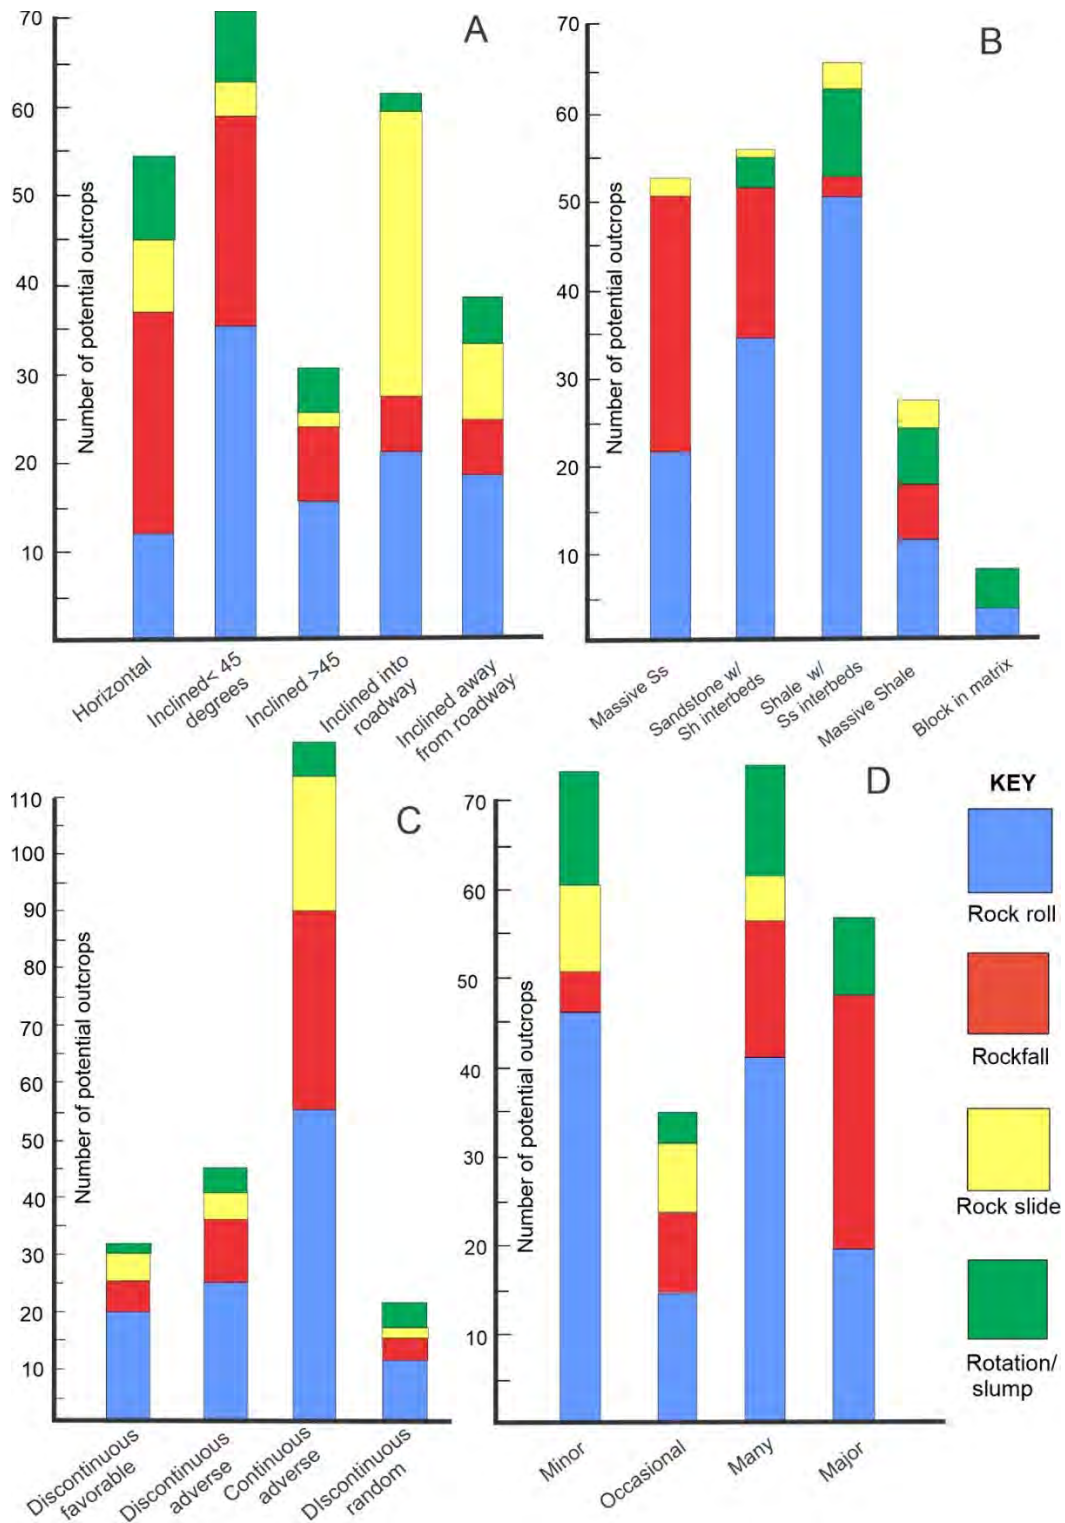
The orientation of stratification was judged to be a significant contributing factor in roadway slope failures (Figure 22A). Based upon inferences derived from these data, rockfall potential appears to be highest within strata that are either horizontal or are inclined parallel to the roadway, but at less than 45 degrees. The potential for rock roll is deduced to be relatively constant across the varying strata orientations. The only exception is a minor increase in the potential for cases where bedding is parallel to the roadway and inclined at less than 45 degrees. Rockslide probability is generally low, except where strata are inclined into the roadway. Slumps or rotations do not seem to be substantially related to stratification.

Based on outcrop numbers, lithology was considered a significant geologic factor contributing to potential slope failure (Figure 22B). Allegany County data demonstrate that rockfall potential is substantially higher within massive lithologies than within other rock types. This relationship is somewhat reduced within thick-bedded sandstone and/or limestone units that have interbedded shaly layers. Rockfalls are lower in potential where shale with interbeds of sandstone, massive shale, and block in matrix form the slope. The reason for this relationship may not be directly related to lithology, but it may be tied to road construction techniques. Outcroppings of massive sandstone, or thick intervals of sandstone with shaly interbeds are capable of forming steep-sided rock exposures. As such, excavations passing through these lithologies tend to be steeper than those that pass through rock types that are less resistant to weathering and erosion, like shale. The resulting steep road cuts, therefore, are more prone to rockfall incidence.

One geologic factor that appears to play a substantial role in the potential for roadway slope failure is the character of the fracture planes within the rock unit (Figure 22C). Fracture planes that are continuous and adverse to the roadway appear to be correlative to most types of failures. This type of fracture system was interpreted to be responsible for 57% of potential failures in the outcrops studied. No other joint or fracture characteristic was responsible for more than 20% of potential failures.

Another factor that impacts the likelihood, degree, and type of slope failure is the extent of differential erosion (Figure 22D). This figure illustrates the increased potential for rockfalls where major amounts of differential erosion are present. This is because significant amounts of differential erosion create over-steepening of slopes and lead to a greater likelihood of rockfalls. Also, rock roll can be shown to have an increased potential where many differential erosion surfaces exist. Differential erosion does not appear to play a significant role in the creation of rockslides or slumps and rotations. As discussed in the earlier section on differential erosion, this feature is related to both the weathering rate and lithology. Because differential erosion or differential weathering is more pronounced in interbedded lithologies, it would appear to have a greater tendency to produce loosened rock fragments within those lithologies. Figure 23 illustrates this relationship between differential erosion and lithology. Contrary to a priori notions, massive lithologies that are resistant to erosion, such as sandstone and limestone, as well as those resistant lithologies with thin interbeds of shale display a definite differential erosion potential. Meanwhile, shales with lesser amounts of interbedded sandstone and/or limestone and massive shales tend to produce lower levels of differential erosion potential.

Figure 31. Geologic factors related to slope failure. A, Stratification and potential failure type. B, Lithology and its potential frequency in failures. C, Character of fracture planes and relations to slope failure type. D, Amount of differential weathering and its potential relationship to type of slope failure.

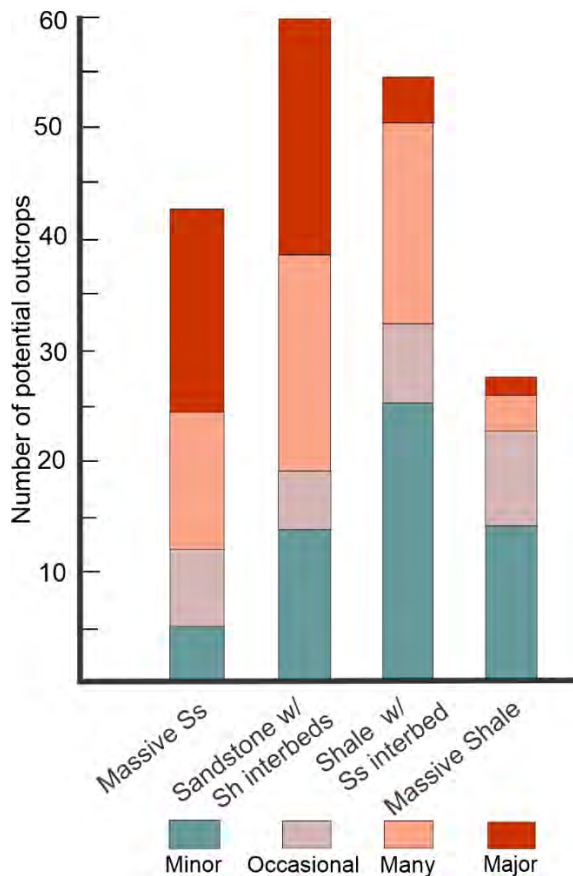
Figure 32. Lithology and its potential relationship to differential erosion.
